McEntire ANGB PEM Demonstration Project Final Report

Proton Exchange Membrane (PEM) Fuel Cell Demonstration Of Domestically Produced PEM Fuel Cells in Military Facilities

> McEntire Air National Guard Base Main Base Fire Station Columbia, South Carolina

> > Aug 4, 2006

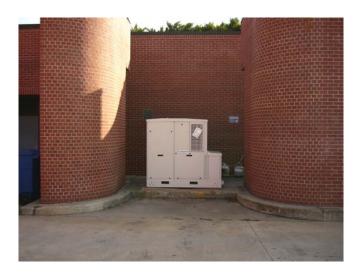
Figure 2 - Fuel Cell Pad Site

The photo above in <u>Figure 2</u> shows the Plug Power Gensys5C fuel cell on its pad in a niche formally occupied by a trash dumpster. The unit was delivered on October 15, 2004. Providing gas service for the fuel cell presented a new challenge for LOGAN, since the closest natural gas tie-in is on the roof of the building, some 100 feet from the unit. The safety concerns associated with running a connection to the natural gas line over such a long distance forced LOGAN to reconsider the proposed pad site in hopes of finding a more convenient location.

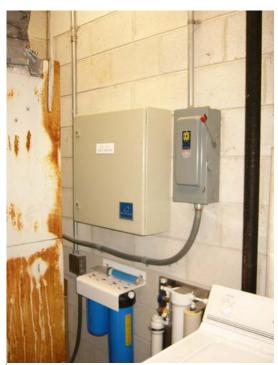
Figure 5 - Filtration/Comm. Hardware

From the perspective in <u>Figure 4</u>, it is easy to see the maintenance disconnect panel and accompanying electric meter mounted on the bracket attached to the fuel cell. Inside the mechanical room, located just to the right in <u>Figure 4</u>, LOGAN technicians mounted both the Connected Energy communications hardware and the reverse osmosis water filtration equipment. These components can be seen pictured below in <u>Figure 5</u>.

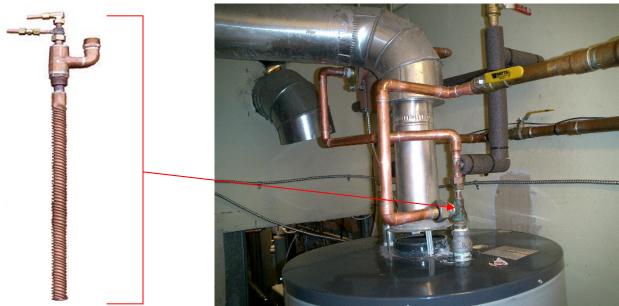
Figure 7 – Solar Wand Installation

Hot water tanks with built in heat exchangers are not usually available at water heater retail outlets, which makes this component particularly attractive in this application. Figure 7 below shows the Solar Wand component on its own as well as a close-up of the exchanger installed on a fire station water heater.
